TECH TIPS

Subaru Service and Technical Support Line Newsletter

January 2017
SUBARU

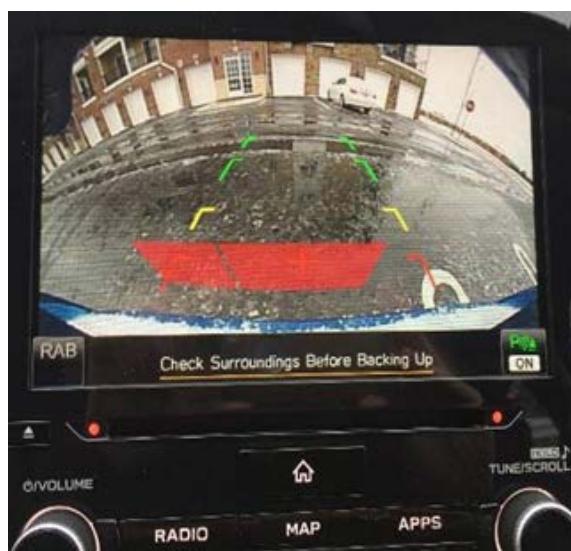
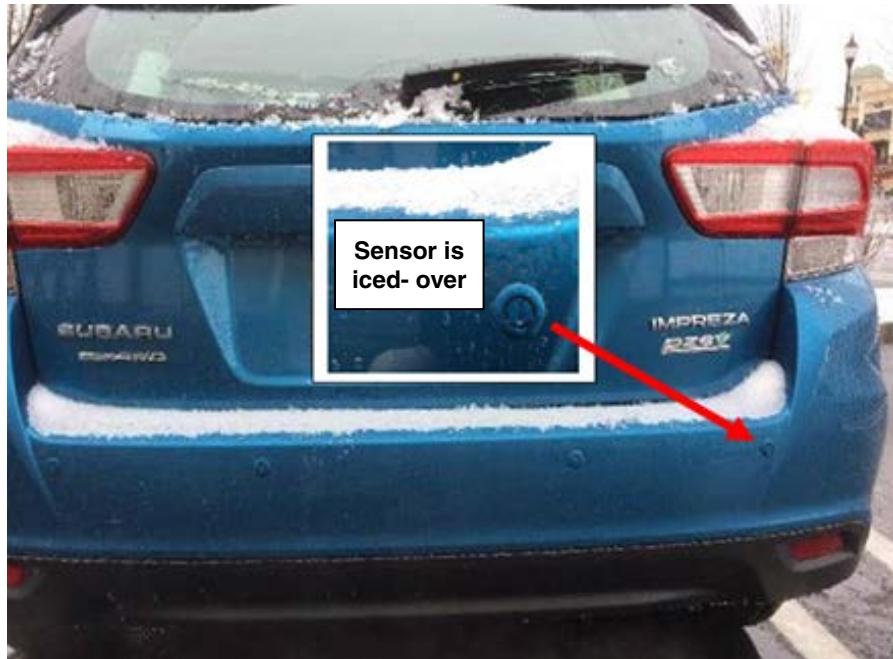
06**2017MY IMPREZA WITH REVERSE AUTOMATIC BRAKING (RAB), RED AREA APPEARS IN BACK-UP CAMERA DISPLAY**

If a customer states they see a red box or area in their back-up camera display, the system may very well be operating as designed. Always perform a visual check of the sensors on the rear bumper first. If any of the sensors are covered over or obstructed by ice and / or snow, the RAB system may not function properly and the red area shown in the example photo below will most likely appear. When this occurs, the RAB system is unable to properly differentiate between what really is an obstacle and what is not. In this case, the sensor is iced over and the red area is displayed with no obstacle present. The Owner's Manual provides a list of other potential causes for this condition to occur:

- In the following cases, the system may not be able to properly detect an obstacle. Promptly contact a SUBARU dealer to have the system inspected.

- A sticker, paint, or a chemical is applied to the rear bumper near the sonar sensor
- The rear bumper is modified
- The rear bumper has been removed and reattached
- The ground clearance is changed due to the vehicle's loading condition or modification
- Ice, snow or mud is adhered to the rear bumper near the sonar sensor
- The rear bumper is exposed to strong impact, or the rear bumper is deformed

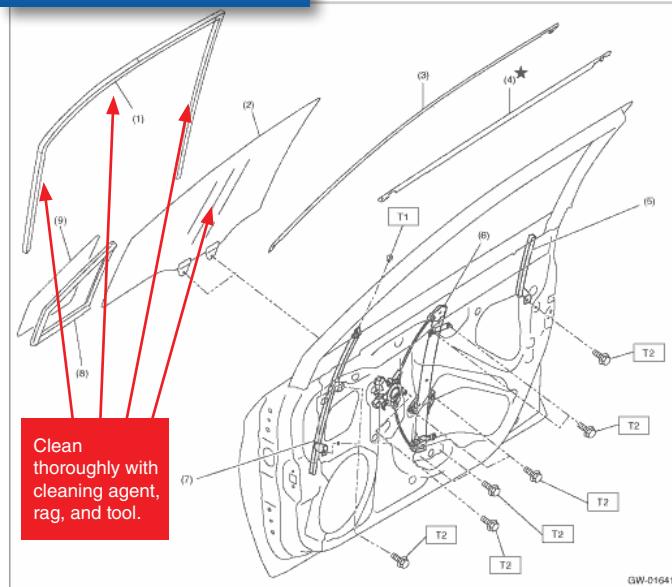
07**POWER WINDOW OPERATION ERRATIC, CANNOT PROGRAM MEMORY.****Figure 1 – Front Door Glass**

If you encounter a power window that will not fully close when using the auto up/down feature, then re-opens slightly, there are a few items which should be inspected before proceeding with component replacements. Typically, when this condition occurs, the power window controller within the window switch has recognized an unwanted variation in motor speed indicating an object blocking the window from closing. In order to prevent damage, or possible injury, the auto-reverse function will be enabled and the window will move in the reverse direction. When the window operates in auto-reverse mode, this results in window memory loss. We would like to provide inspection points and helpful tips to use when diagnosing this condition and programming the window memory as outlined in the Service Manual:

- Using a cleaning agent, rag, and plastic trim tool, clean the run channel seal and window glass thoroughly of dirt and debris that could potentially cause a binding condition. ➔ (See **Figure 1**)
- Inspect the run channel seal for bulging, proper fit, and placement in the run channel.
- If the vehicle has been in a collision with the door exhibiting the window issue, inspect installation of all affected components.
- Repeated attempts at learning the window memory could potentially overheat the motor, resulting in further difficulties. Allow the window motor to cool before proceeding with any further testing.
- The logic for the Auto-Reverse function is housed within the power window switch so, swap with a known good vehicle to test functionality.

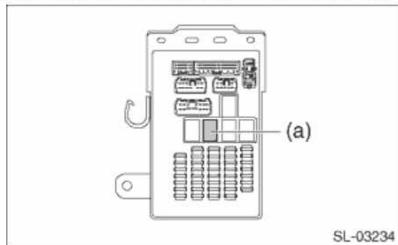
Figure 1 – Body Integrated Unit Replacement on 2015 Outback

The Techline continues to receive calls from Technicians about issues after replacing a BIU. For example, not switching the Factory Initial Setting from “Factory” to “Market” typically results in the pocket lights, dome lights, and key ring flashing. As shown below in **Figure 1**, prior to replacing the BIU it is required to check and record the current customized settings. This can be achieved through the work support function utilizing the SSM4. More information on this can be found in the April 2016 TechTIPS Newsletter. Once BIU installation is complete, the unit must be customized to match the recorded settings.

- When the body integrated unit is replaced, registration of the immobilizer is required.
For detailed operation procedure, refer to the “REGISTRATION MANUAL FOR IMMOBILIZER”. (Models without the keyless access with push button start)
- When replacing the body integrated unit, install the starter relay (a) to the relay holder.

1. Set the current settings as recorded.

2. Register the immobilizer. (Models without the keyless access with push button start, and except for C0 and C5 models)

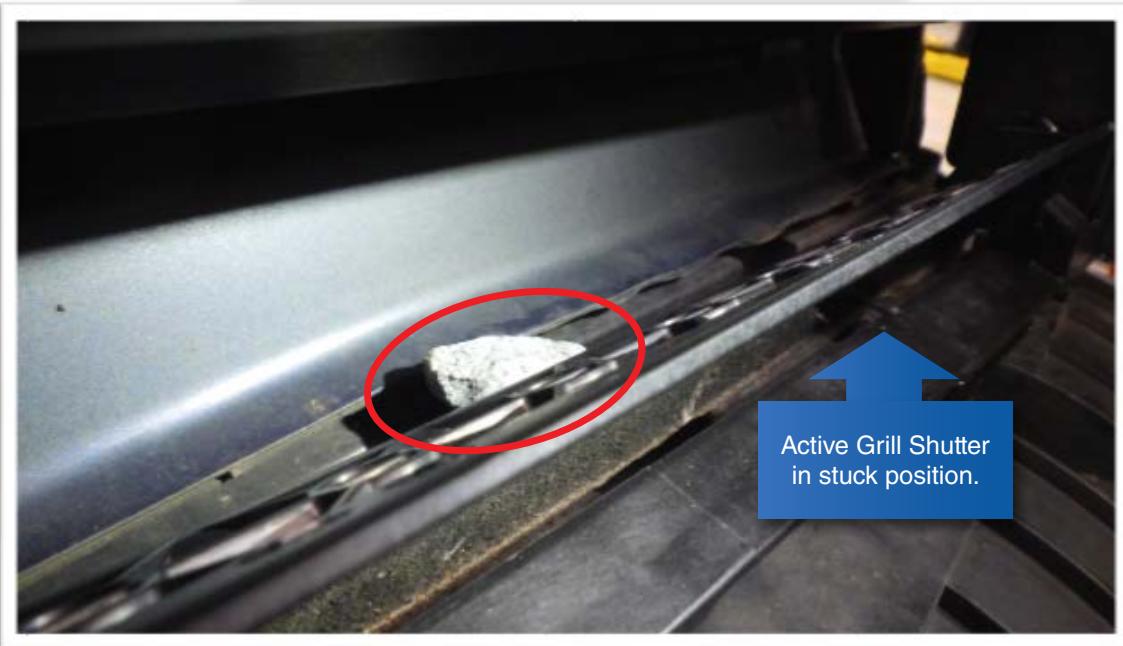
Figure 1 – Rock stuck in AGS

If you encounter DTC P05A0 ACTIVE GRILLE SHUTTER “A” STUCK in any Subaru vehicle, it is imperative the Active Grill Air Shutter assembly is completely inspected for debris or damage. This DTC is detected when the open or close operation of the Active Grill Shutter is disabled due to foreign debris such as rocks, walnuts, or ice. Using the SSM4, Technicians should **save the FFD** associated with this DTC and proceed to visually inspect the Active Grill Shutter for debris that would prevent proper operation. If there are no visible debris present that would prevent operation, front bumper cover removal is required for an inspection. Below in the image labeled **Figure 1** is a rock that prevented operation of the Active Grill Shutter, and could not be seen with the bumper cover installed.

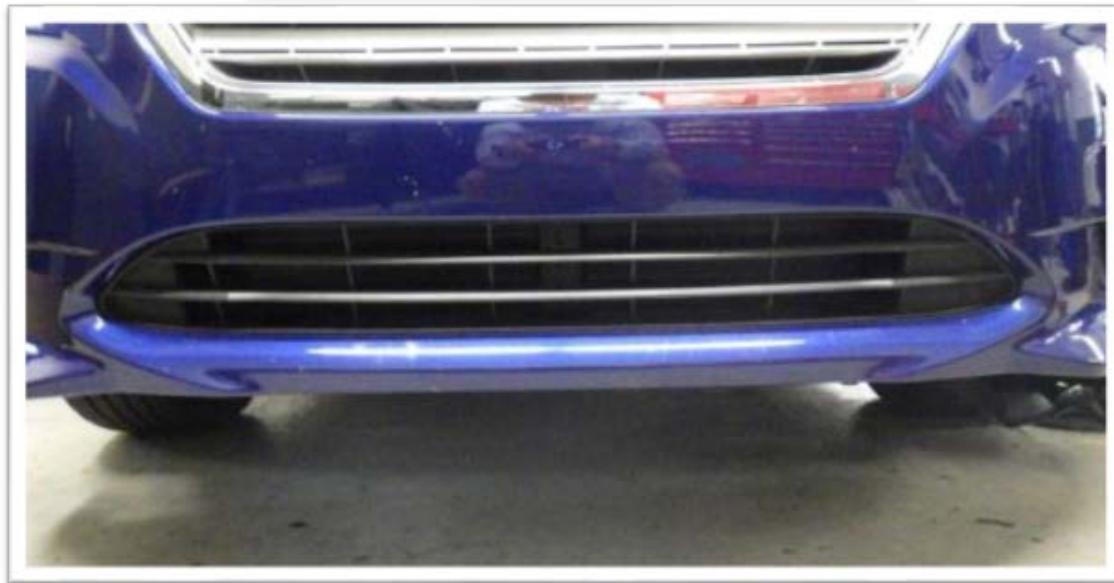
Figure 2 – Bumper Cover Installed

Now below in the image labeled **Figure 2**, you can see how difficult it would be to see this obstruction with the front bumper cover installed.

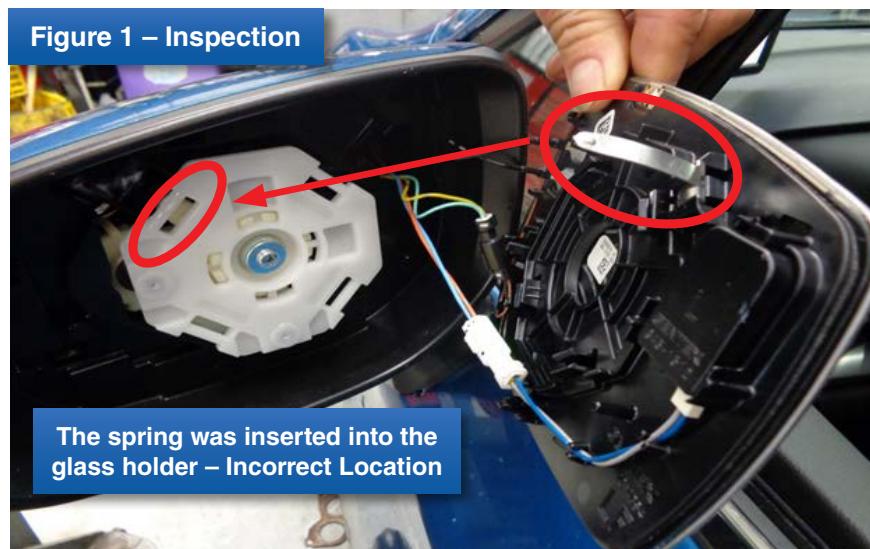
There have been reports of the exterior mirror glass not traveling its full range of motion on the 2017 Impreza equipped with exterior auto-dimming mirrors. Upon further investigation, it is possible the Friction Damper Spring could have been inserted into the incorrect position resulting in the condition. If the friction damper spring is not located in the correct position it will limit the amount of travel for the mirror glass. We have provided an inspection and repair procedure to address this concern as outlined below.

Remove the mirror glass from the mirror housing as outlined in the Service Manual and inspect the position of the friction damper spring as seen in **Figure 1**. Depending on its position will determine if the spring was installed in the correct slot.
