ARTICLES CONTAINED IN THIS ISSUE

CODE	ARTICLE.....	PAGE
(00)	STIS New Releases	9
(01)	QMR of the Month	1
(01)	Subaru-U.....	2-3
(03)	2017MY Impreza: Audio volume turned to MAX when monitoring Infotainment Data Monitor	4
(06)	Hill Start Assist Light On But No Codes.....	4
(11)	ELCM Self Testing For Diagnosis	5-6
(15)	2017MY Impreza- Serial Numbers on Gen 3 Harman Audio Units	7
(15)	2017MY Impreza Key Start Res Tips	8

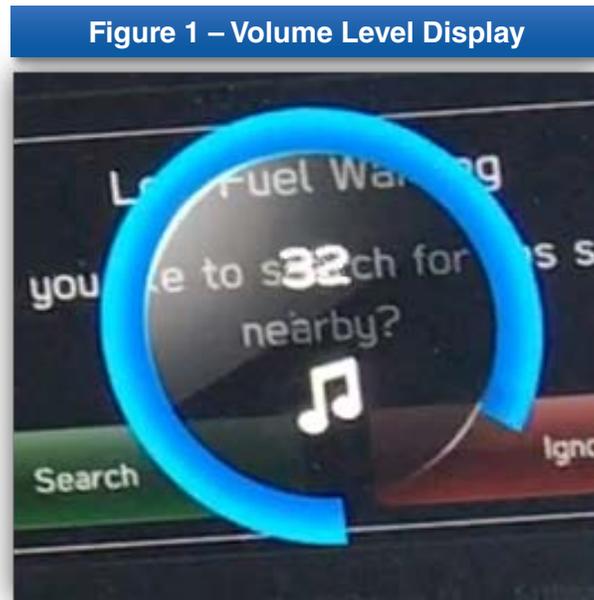
If you are monitoring the Infotainment System Data Monitor and the volume level display (**Figure 1**) appears showing the volume level increasing but the sound level remains the same, this is a normal operation of the Harman unit. When Technicians access the Infotainment System Data Monitor, the unit enters “Diagnostic Mode” and the volume level will be displayed in this manner. No repairs should be performed on the unit to address this concern as it is a normal operating characteristic.

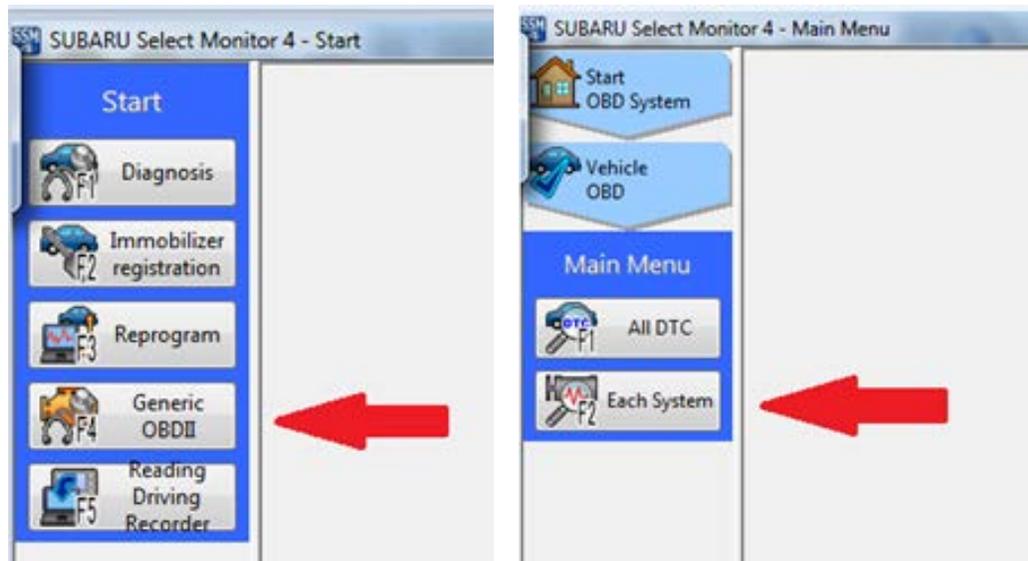
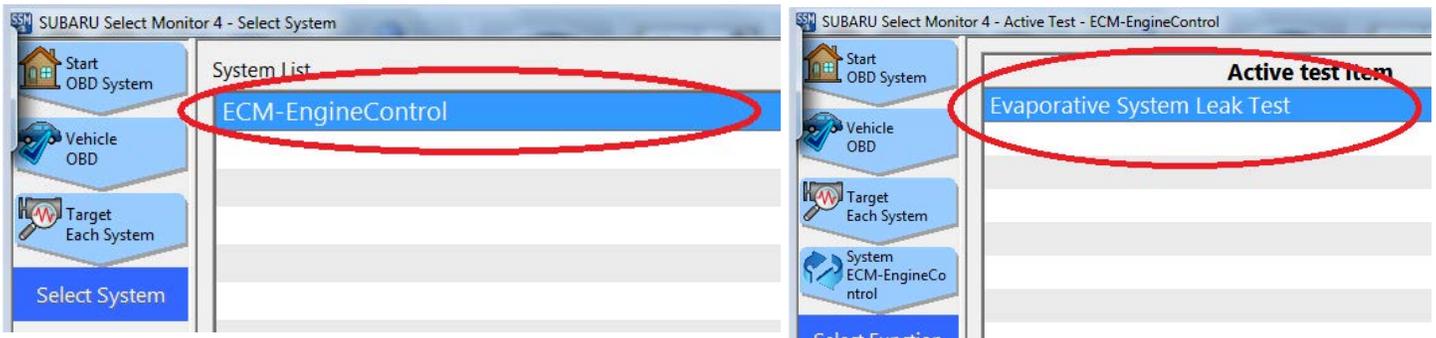
See below for SSM 4 screenshots of how to access the self-test.

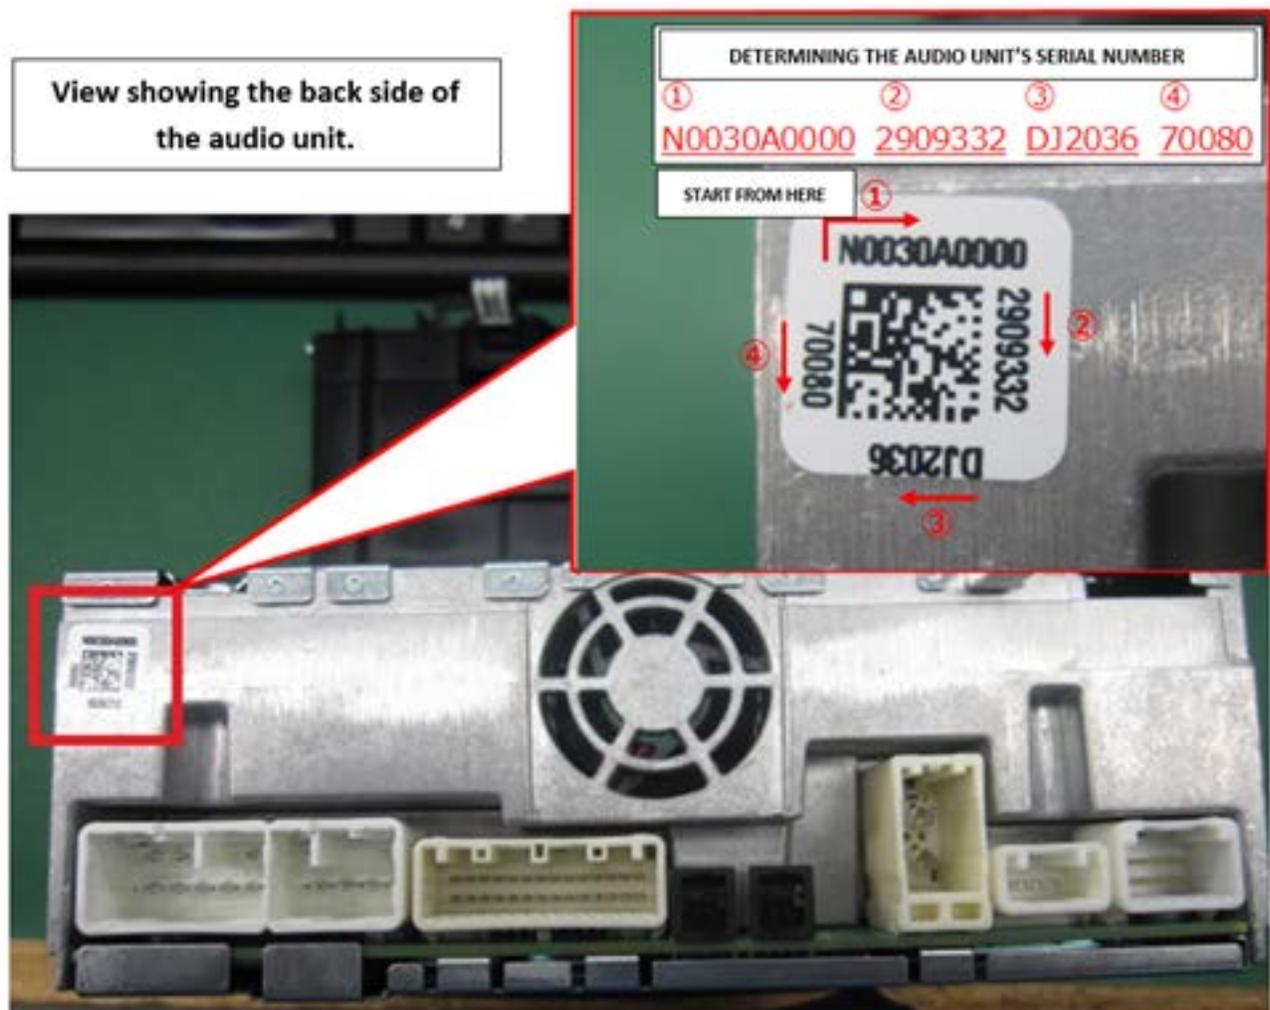
If the audio unit serial number is ever needed for a Gen 3 Harman audio unit, it can be found on the back panel as shown in the photo and inset below. **CAREFULLY** remove the audio unit following the service procedure in the applicable Service Manual. A small sticker with a QR code surrounded by 4 numeric segments which make up the serial number can be found on the back side of the case, upper left corner as shown in the example below. Record the 4-part serial number in order as shown in the inset.

REMINDER: Always take all proper precautions to protect the surrounding dash trim components from damage.
