ARTICLES CONTAINED IN THIS ISSUE

SUBARU OF AMERICA

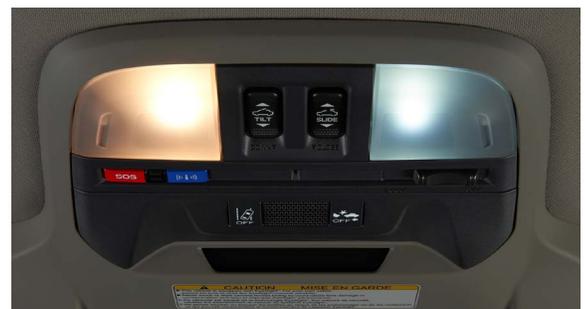
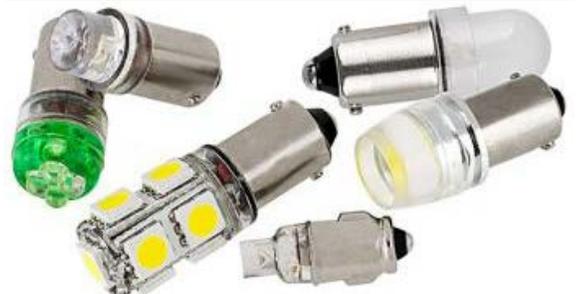
The Techline continues to receive calls where a customer has decided to use an aftermarket lighting source. We have seen multiple issues when LED or HID lights are added to the vehicle. Most common issues include but are not limited to DTCs, abnormal electronic component operation and control module failure. It is recommended that during your pre-inspection any odd looking light source be verified original before moving forward with diagnosis. If aftermarket lighting is identified, we would recommend returning the vehicle to factory specifications or offer an LED Upgrade – Map and Dome Light Kit (H461SFL100), if applicable, then proceed with the appropriate diagnostics.

Pictures of aftermarket bulbs.
