ARTICLES CONTAINED IN THIS ISSUE

CODE	ARTICLE.....	PAGE
(00)	STIS New Releases	9
(01)	QMR of the Month	1
(01)	Subaru-U.....	2-3
(03)	2017MY Impreza: Audio volume turned to MAX when monitoring Infotainment Data Monitor	4
(06)	Hill Start Assist Light On But No Codes.....	4
(11)	ELCM Self Testing For Diagnosis	5-6
(15)	2017MY Impreza- Serial Numbers on Gen 3 Harman Audio Units	7
(15)	2017MY Impreza Key Start Res Tips	8

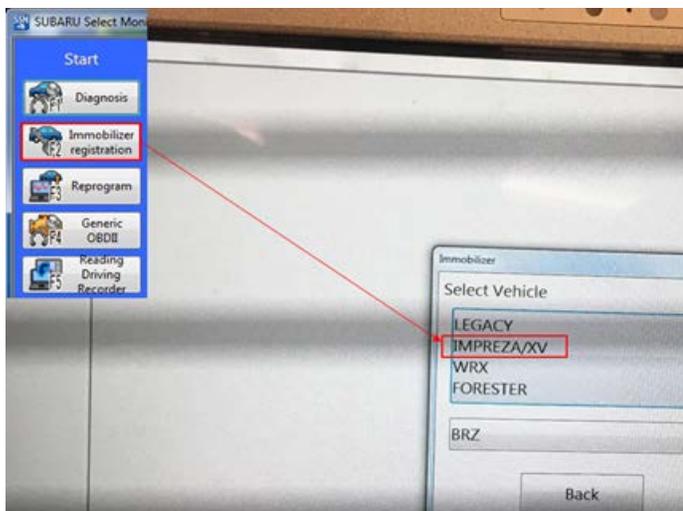
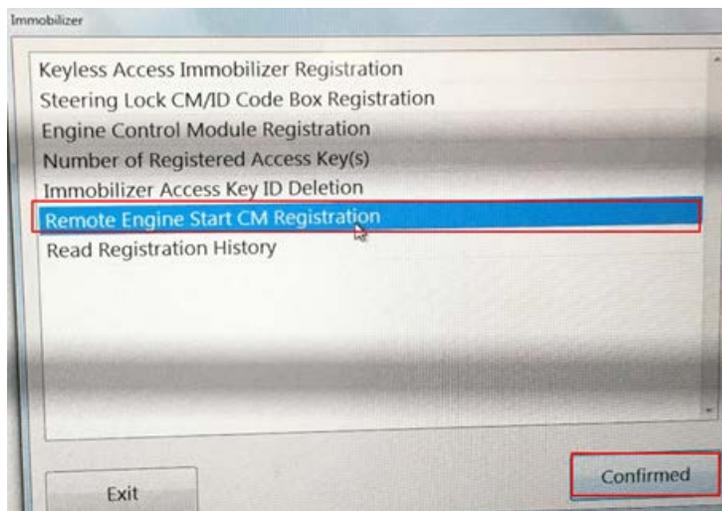
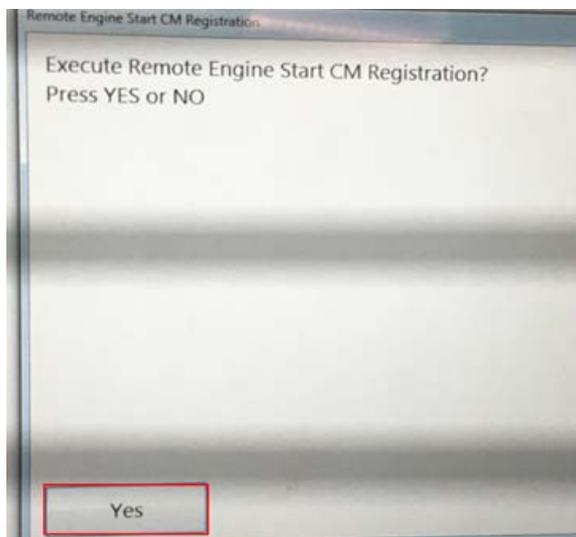
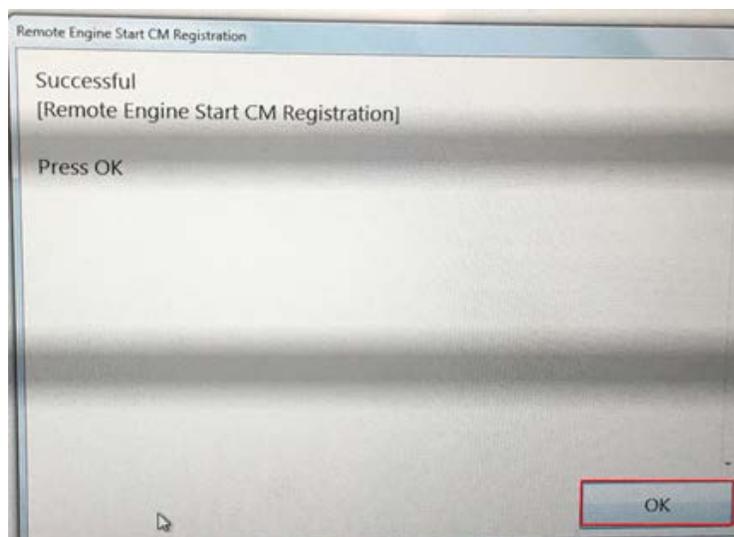
- The registration must be completed within 2 minutes or it will fail.
- The vehicle must be in Park.
- The DST-i firmware must be updated to the latest version (as of now 2.4 is the latest).
- The destination setting of the DST-i must be set to North America.
- If the registration cannot be completed using the DST-i in stand-alone mode, try using SSM4.
